This is the standard setup on the Falco

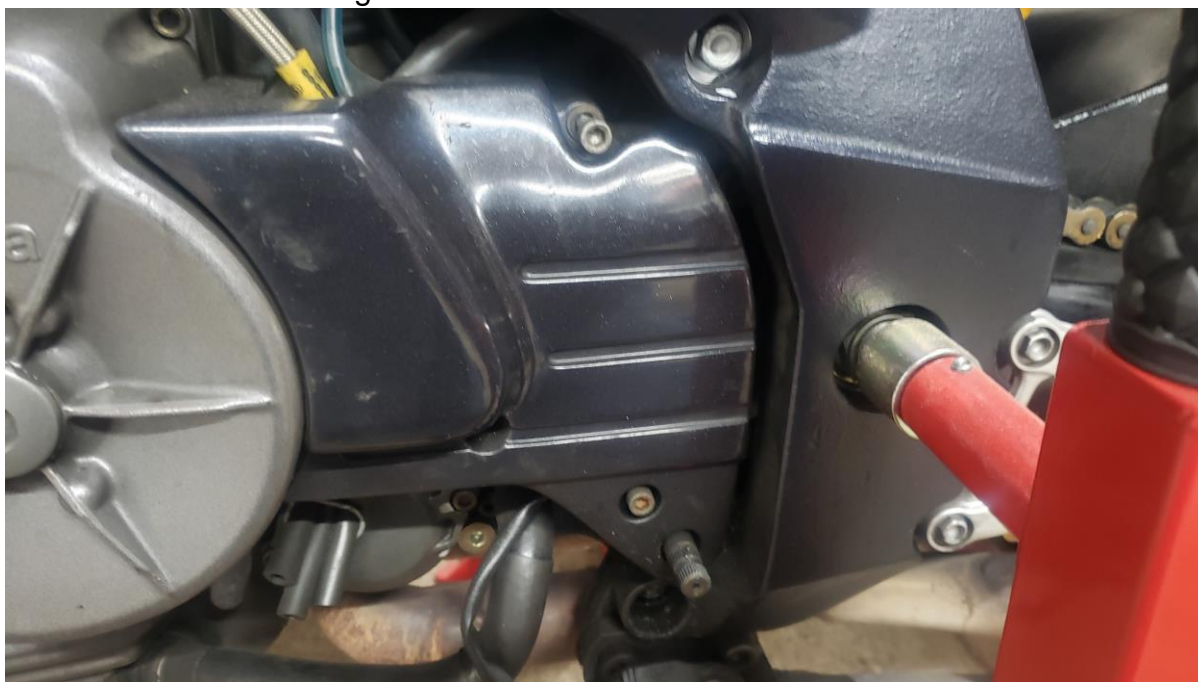
Cover loosened and the gear arm removed

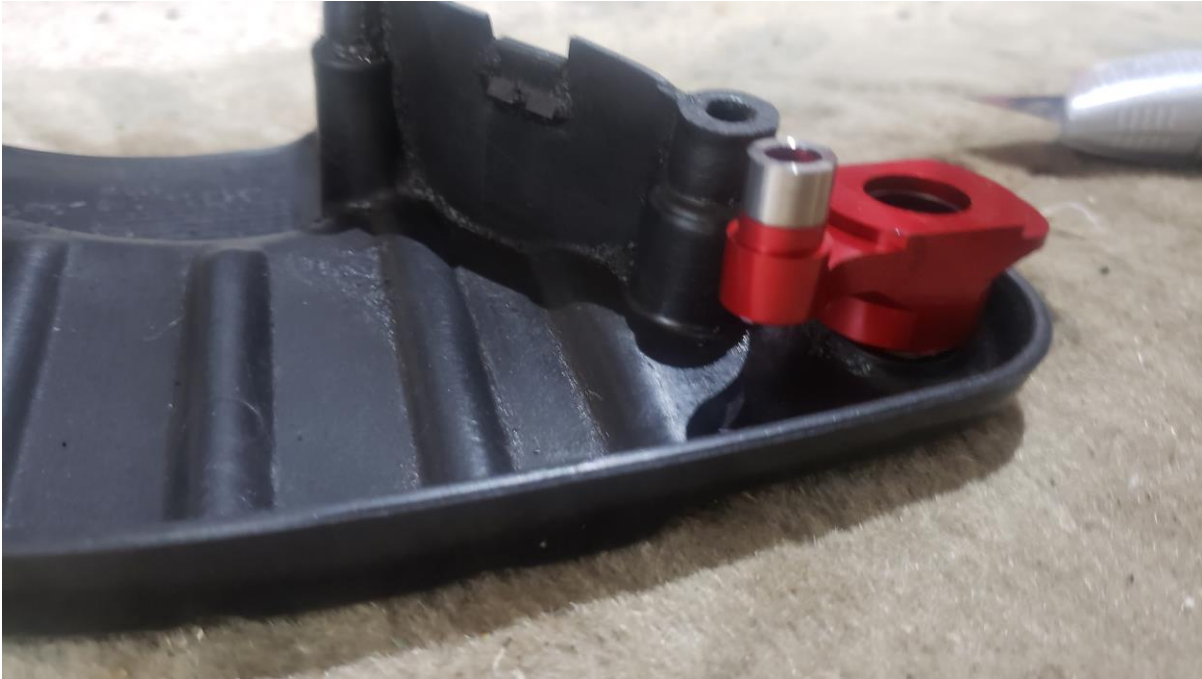
Support bracket on O/E cover to demonstrate what needs to be trimmed

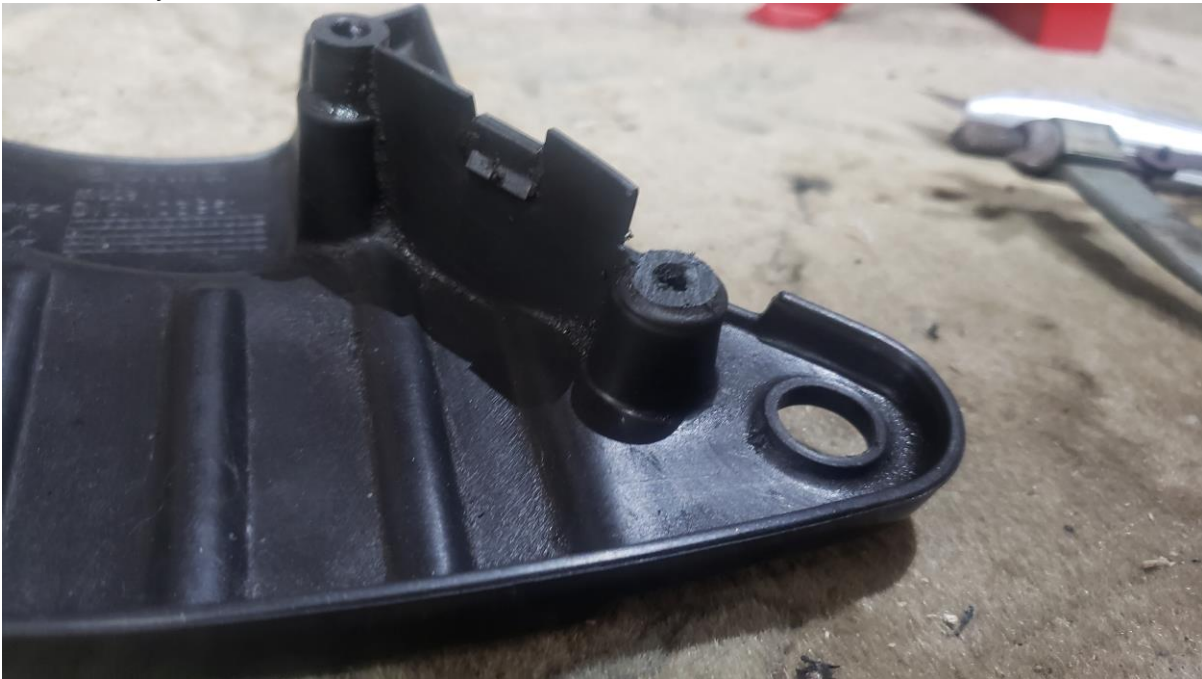
1st cut away a little of the web and take the narrow section off the bolt channel

- a step drill to reduce the lip on the inside of the cover
- a Stanley knife to cut the thin web
- a hacksaw to remove the thin part of the bolt channel
- a smaller step drill to open up the wider part of the bolt channel
- a Stanley knife to cut the notch in the bolt channel

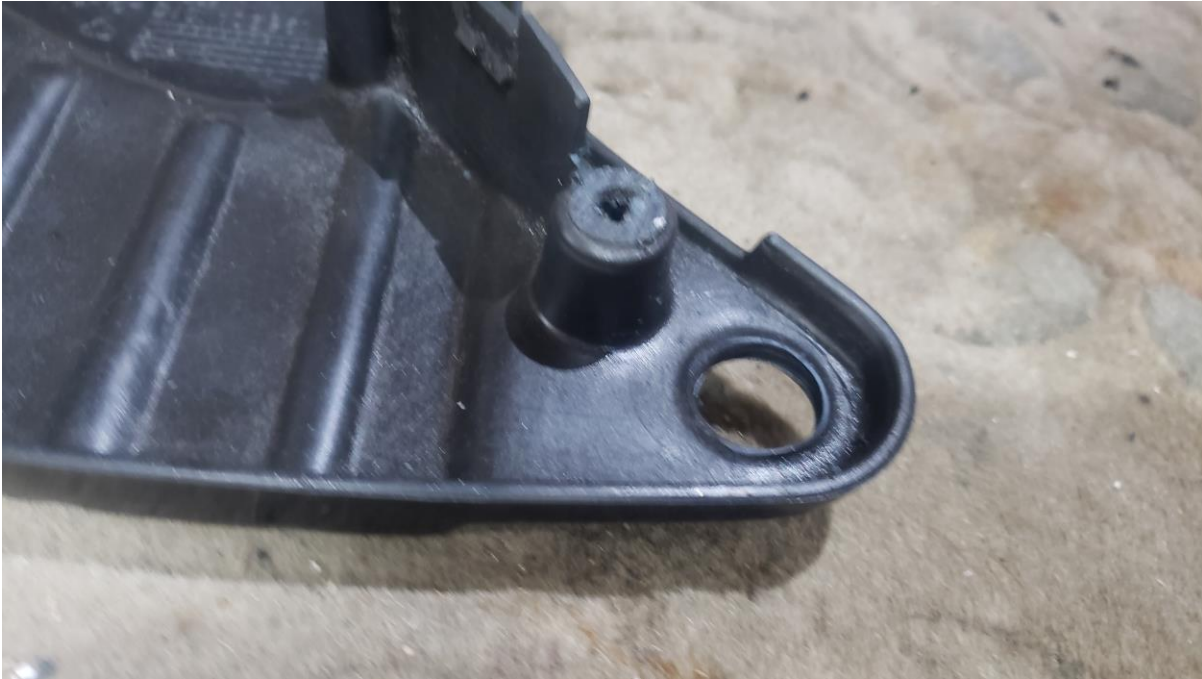
Then I used a step drill to reduce the lip on the O/E shaft hole

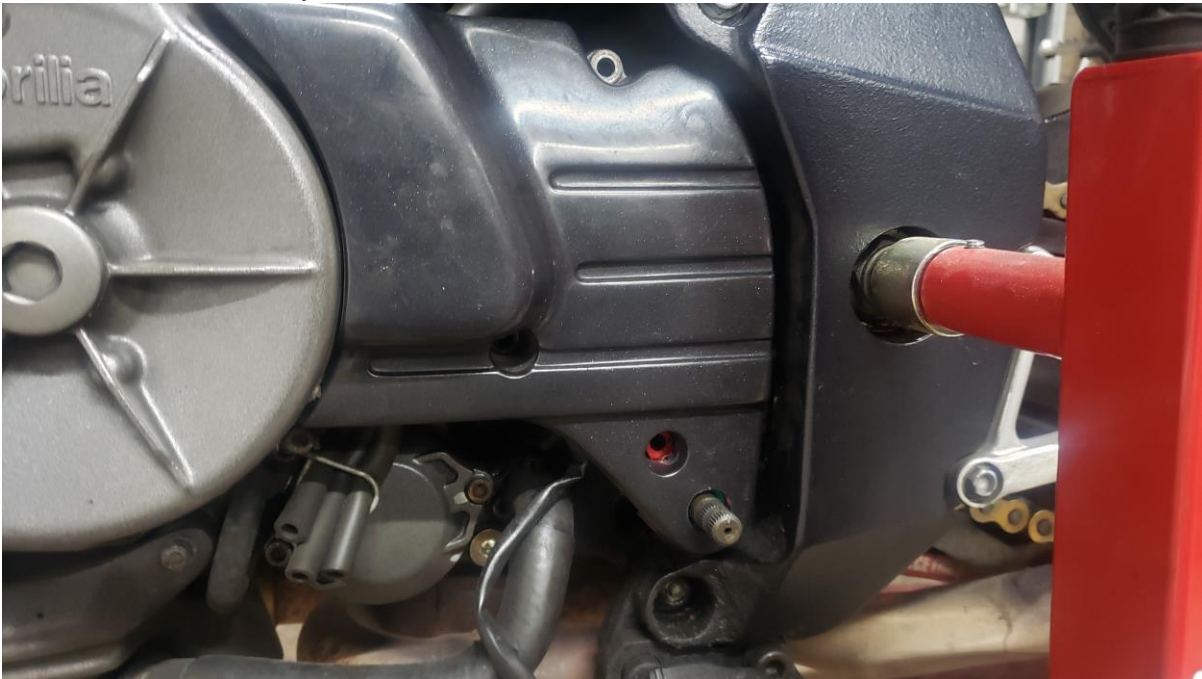
Test fit, still needs adjustment

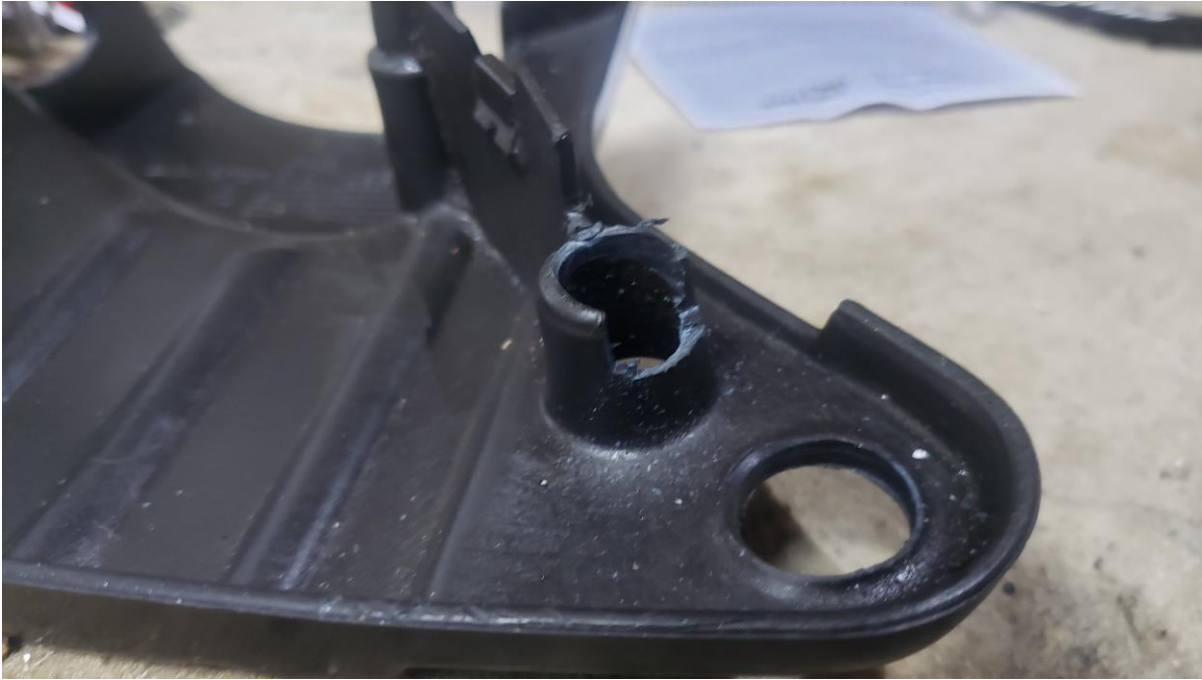
I had to open up the bolt channel completely using a step drill and cut a channel to accommodate the support bracket.

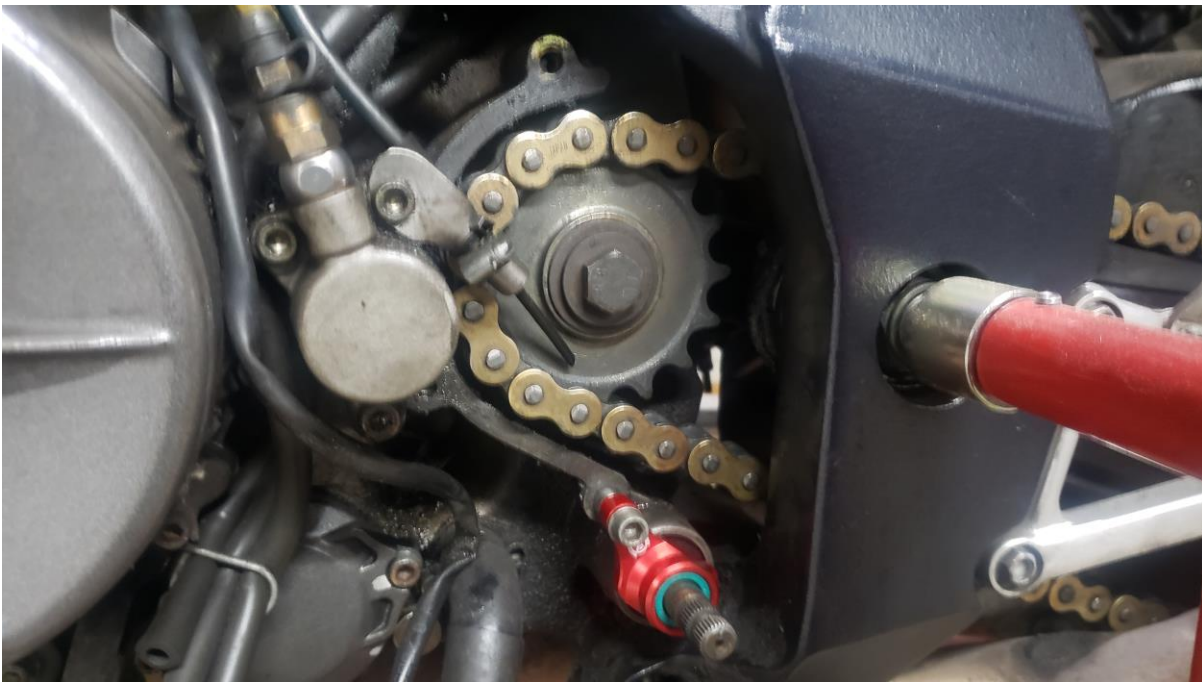
Bracket mounted
